South Fork HOA Waterway Inspection Report

Reason for Inspection: Scheduled-recurring

Inspection Date: 1/27/2020

South Fork HOA

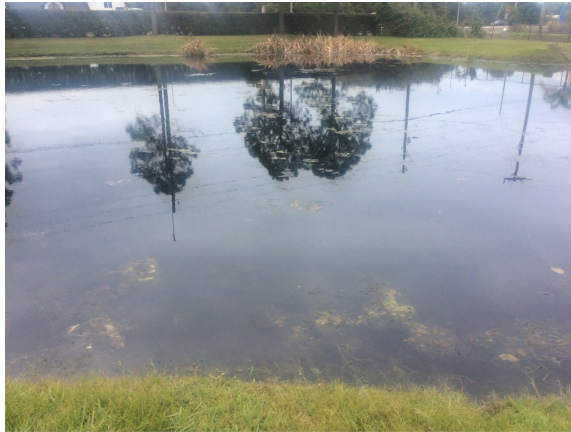
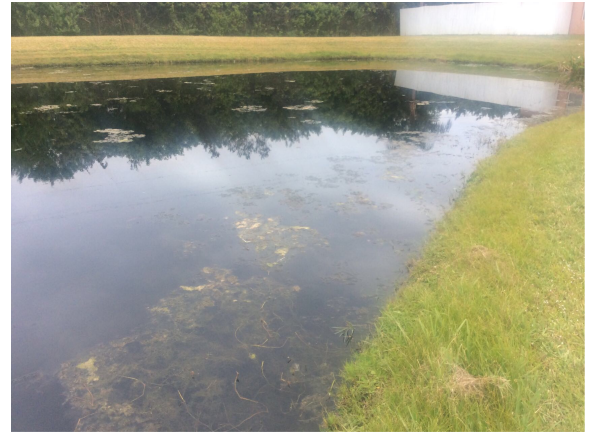
Site: 1

Treatment in progress

Sporadic growth of algae and slender spikerush was present during inspection. Positive results following recent treatment notable.

Submersed vegetation

Pond #1: Sporadic growth of algae and slender spikerush was present during inspection. Positive results following recent treatment notable.

Routine maintenance next visit

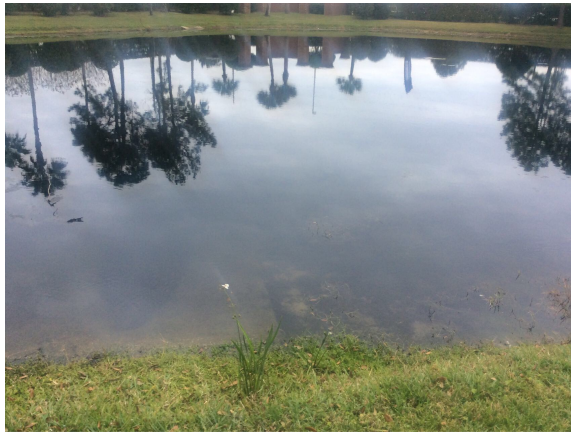
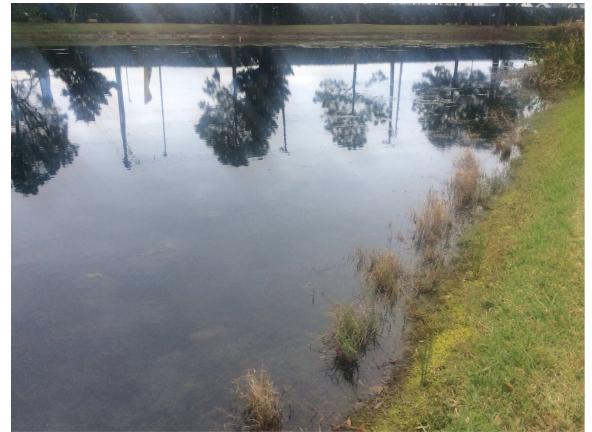
Site: 2

Treatment in progress

Torpedo grass along perimeter noted with positive treatment results. Sporadic patches of algae present along eastern cove.

Shoreline weeds

Pond #2: Torpedo grass along perimeter noted with positive treatment results. Sporadic patches of algae present along eastern cove.

Routine maintenance next visit

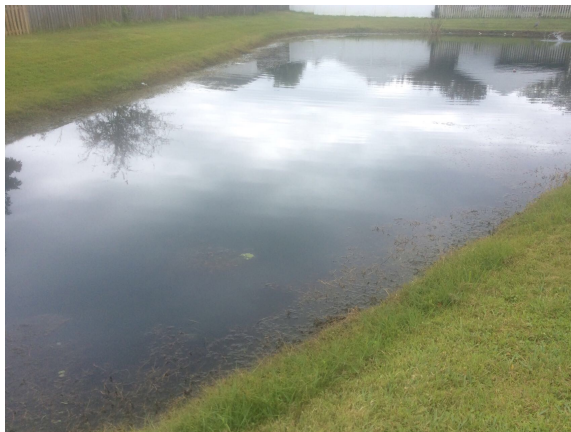
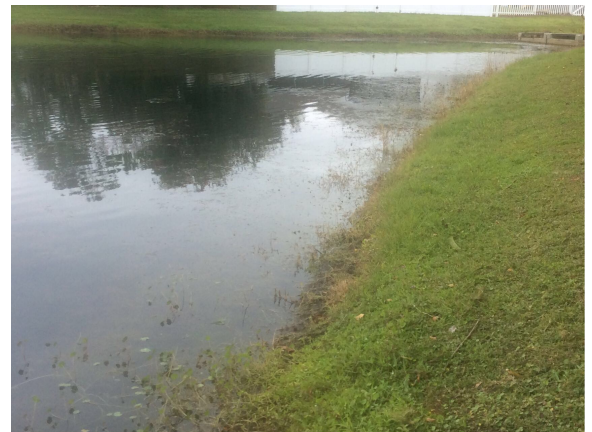
Site: 3

Treatment in progress

Slender spikerush and algae along pond perimeter. Roughly 1 ft. band. Minor torpedo grass and pennywort also present.

Submersed vegetation

Pond #3: Slender spikerush and algae along pond perimeter. Roughly 1 ft. band. Minor torpedo grass and pennywort also present.

Routine maintenance next visit

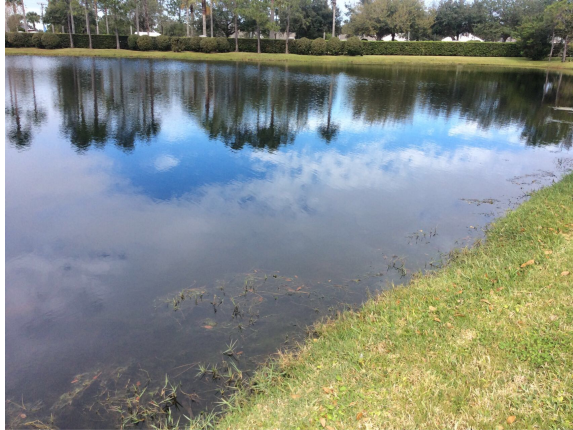
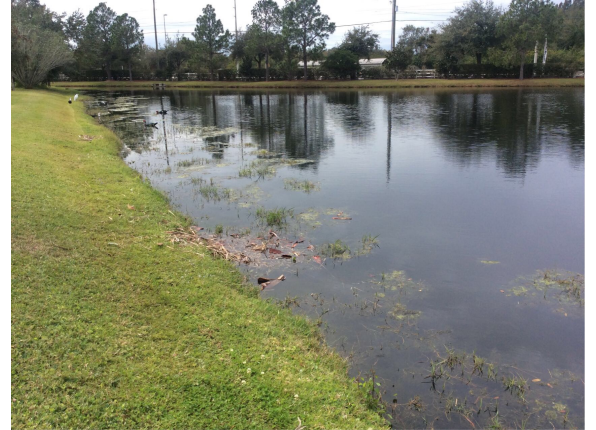
Site: 4

Treatment in progress
Moderate algae noted with evidence of treatment. Grass rhizomes will continue to be aggressively treated during our routine visits.

Surface algae

Pond #4: Moderate algae noted with evidence of treatment. Grass rhizomes will continue to be aggressively treated during our routine visits.

Routine maintenance next visit

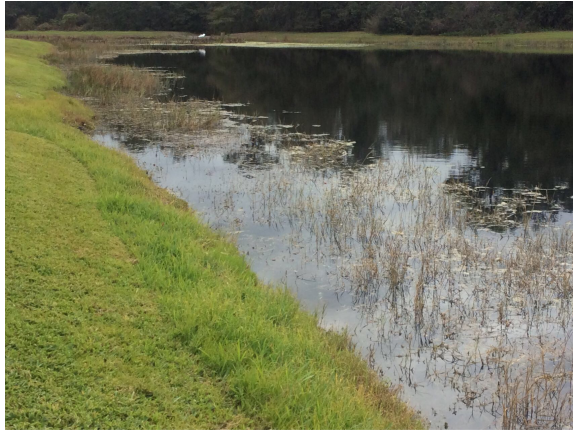
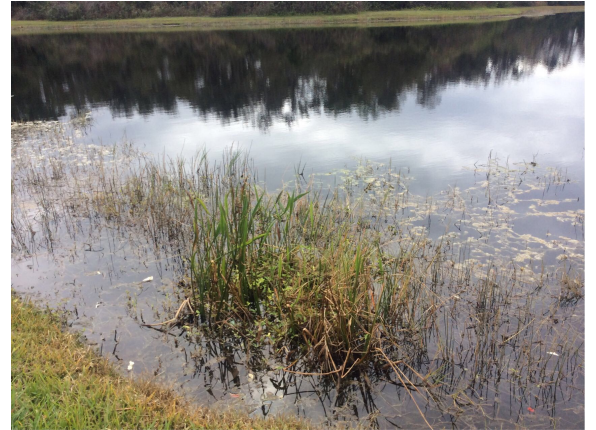
Site: 5

Treatment in progress
Continues to develop algae and slender spikerush. Algae prominent within shelf. Treated during recent visit on 1/23.

Surface algae

Pond #5: Continues to develop algae and slender spikerush. Algae prominent within shelf. Treated during recent visit on 1/23.

Routine maintenance next visit

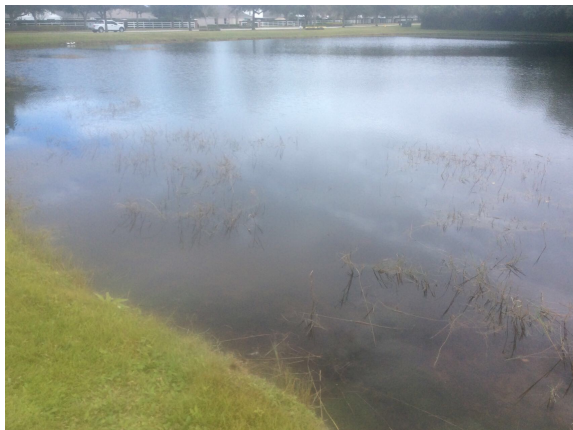
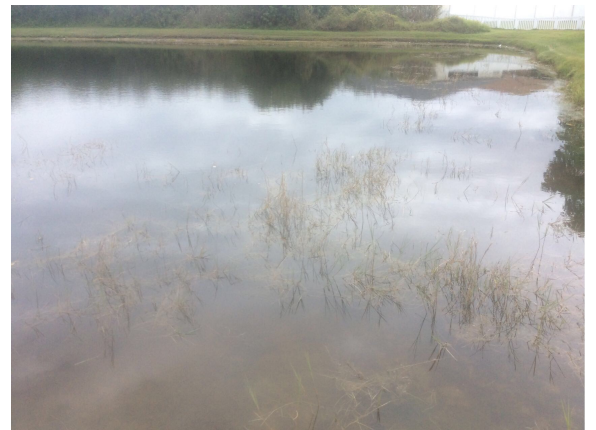
Site: 6

Treatment in progress
New growth of torpedo grass observed within open water to be re-treated during routine visits. Positive results expected within 14-21 days following treatment.

Torpedograss

Pond #6: New growth of torpedo grass observed within open water to be re-treated during routine visits. Positive results expected within 14-21 days following treatment.

Routine maintenance next visit

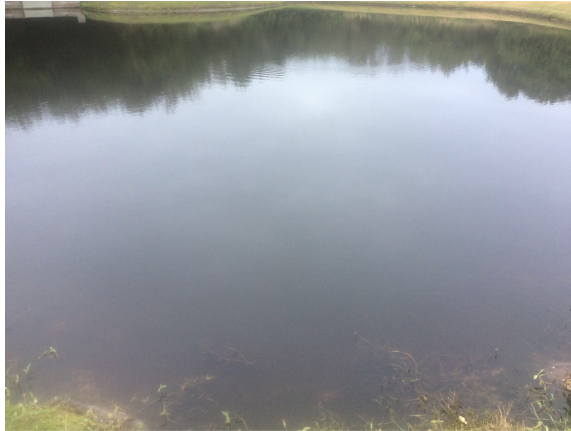
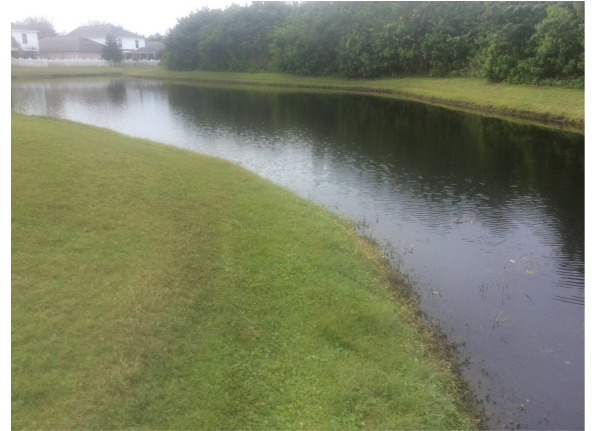
Site: 7

Treatment in progress
Minimal algae and submersed slender spikerush. Overall, looks good.

Alligatorweed

Pond #7: Minimal algae and submersed slender spikerush. Overall, looks good.

Routine maintenance next visit

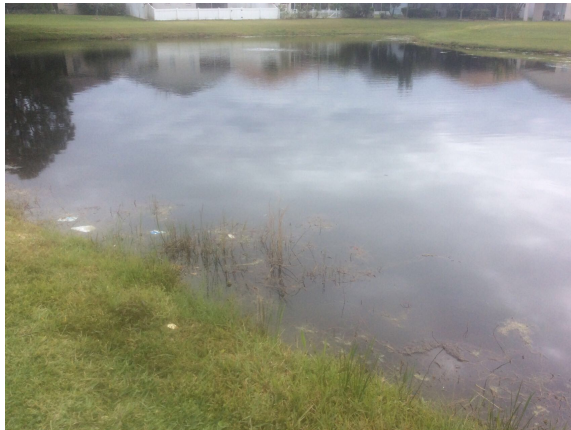
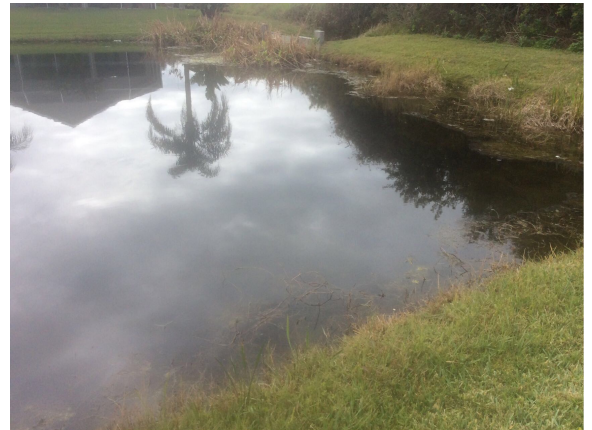
Site: 8

Treatment in progress
Positive results noted. Native vegetation observed with signs of stress common during cooler months.

Surface algae

Pond #8: Positive results noted. Native vegetation observed with signs of stress common during cooler months.

Routine maintenance next visit
